Service Bulletin No. RP20050927 Subject: Rewiring Low Engine Oil Warning Buzzer Model: MVH-406DSY & MVH-306DS2 Product Group: Reversible Vibratory Plates Date: September 27, 2005

# SERVICE BULLETIN

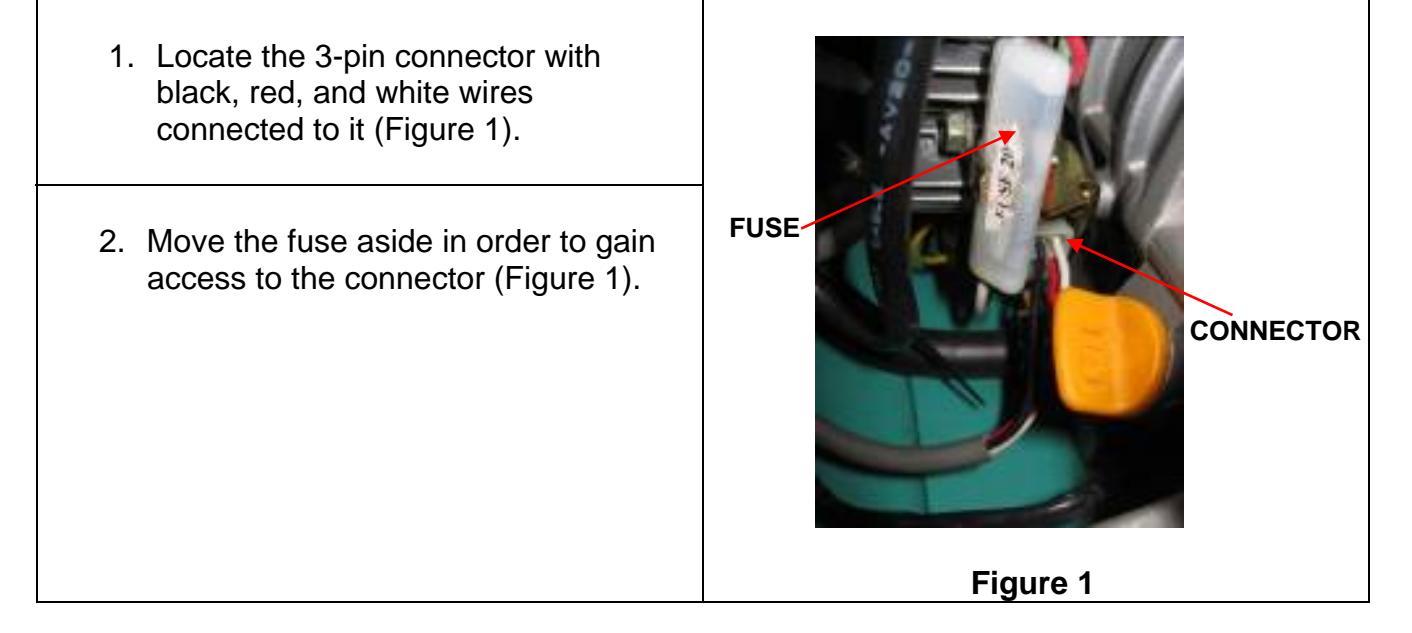
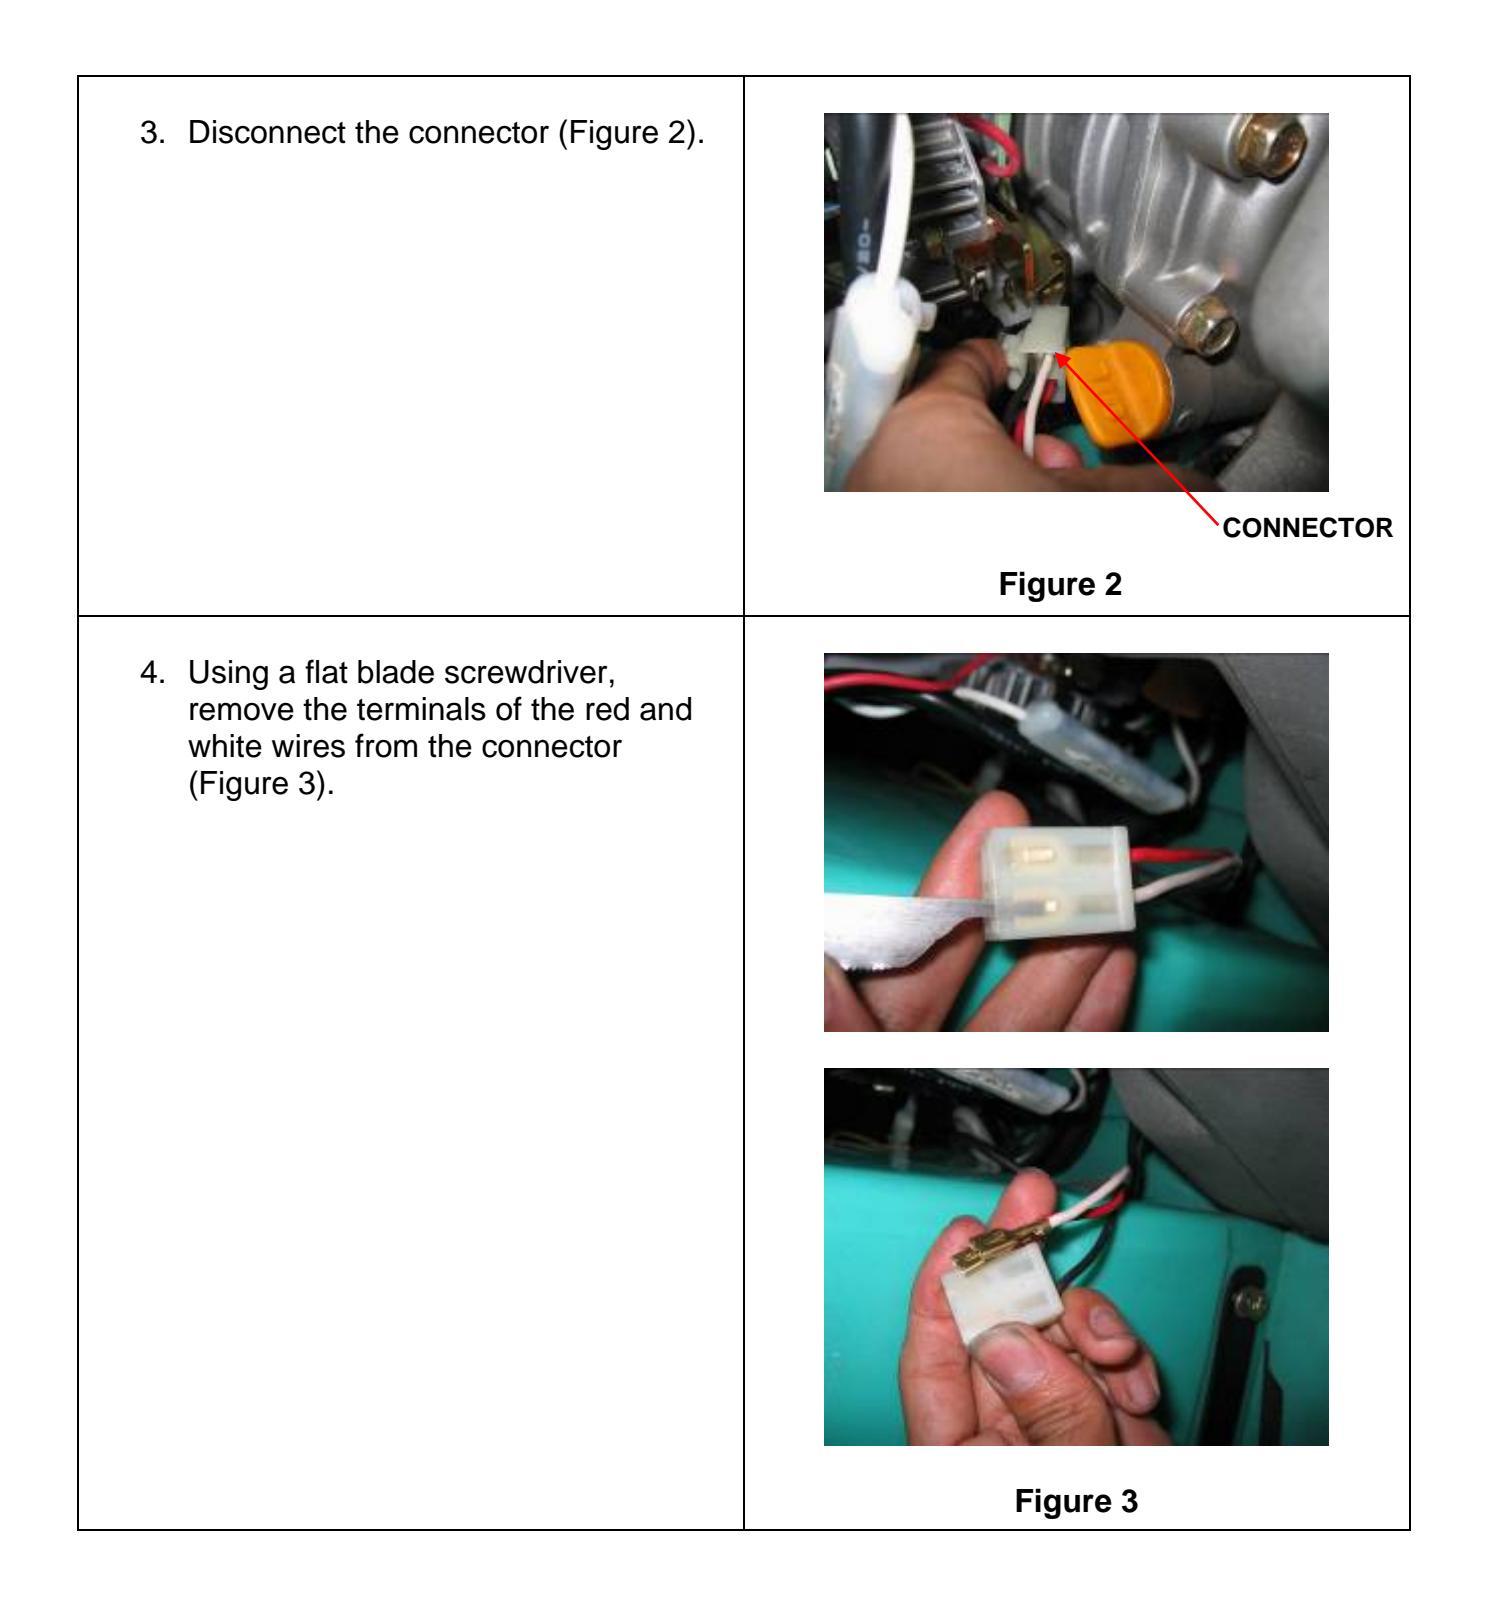
It has been determined that the above referenced units have the low oil warning buzzer incorrectly wired.

These units currently have the warning buzzer wired directly to 12V DC at all times. When battery is installed, the buzzer will sound without the engine running. In order to ensure low oil warning system is functioning properly, perform the following procedure.

- <text>
  - 6. Reconnect the connector and return fuse back in place.
